Lease Crutcher Lewis 3rd and Columbia Demo 801 3rd Ave. Building Seattle, WA

Structural Calculations

These Calculations cover the design of the CDF and rubble berm support of the existing basement walls of the 801 3rd Ave. building. Demolition of the building is in advance of soldier pile shoring installation around the site. The design and calculations for the adjacent 823 3rd Ave building were recently submitted and approved by Ben Enfield at the SDCI. Design methods for this site are similar to the methods used at the 823 3rd Ave site.

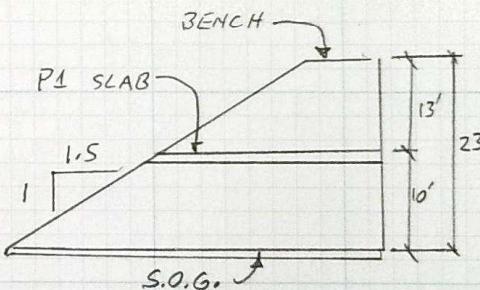
East wall - CDF supported

Coefficient of friction = 0.3 (CDF on Conc par HC e-mail dated 5-5-21)

CDF density = 107pcf (par mix designs from stoneway)

CDF will be pumped to fill all voids below P1 to provide full support.

Sliding on S.O.G.

Total load = 10.4 kif

Try no bench @ slope of $1.5H:1.0V$

Area of CDF = $23ft \times (23ft - 1.5) \frac{1}{2} = 377 sf$

wt. of CDF = $377sf \times 0.107kcf = 40.3 k/ft$

Fractional resistance = $(40.3kif + 3.0kif) \times 0.3 = 12.99 kif$

F.S. = $12.99 kif / 10.4 kif = 1.25$ In.g.

try a 4' bench @ slope of $1.5H:1.0V$

Area of CDF = $377 sf + 4 \times 23 = 469 sf$

wt. of CDF = $469 sf \times 0.107 kcf = 50.2 k/ft$

Fractional resistance = $(50.2 + 3.0) \times 0.3 = 15.96 kif$

F.S. = $15.96 / 10.4 = 1.53$ ok

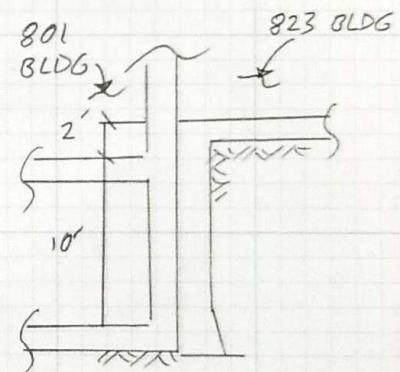
Verify that rubble beam below the P1 slab is adequate to support the soil load from the 823 Building during the construction condition.

sliding resistance = $17.05\text{kif} \cdot 0.3 = 5.12\text{kif}$

$$\text{F.S.} = 5.12 / 3.12\text{kif} = 1.64 \quad \text{OK}$$

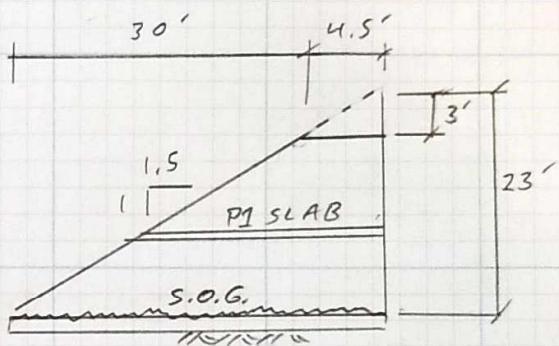
Resistance against Sliding - Roughened surface

Hart crawler in an e-mail dated 5-12 recommends a friction value of 0.4 & a minimum slope of 1.54:1.00 if the CDF is placed on an intentionally roughened surface. Re-evaluate CDF quantities for roughened surface condition.

$$\text{Frictional resistance} = (12.84 \text{ k/ft} + 1.06 \text{ k/ft}) \cdot 0.4 = 5.56 \text{ k/ft}$$

$$\text{F.S.} = 5.56 \text{ k/ft} / 3.61 \text{ k/ft} = 1.54 \text{ (ok)}$$
